Ref. no.: Institution #: 001397072 – Municipal buildings, Kangiqsualujjuaq

Subject: Occupational-health report: air quality in the Kangiqsualujjuaq arena

On April 16 and 17, 2015, as industrial-hygiene technician and regional nurse coordinator for occupational health of the Nunavik Department of Public Health, we visited the Kangiqsualujjuaq arena at your request to investigate an event of respiratory poisoning that affected the players and spectators during a hockey tournament on April 11, 2015.

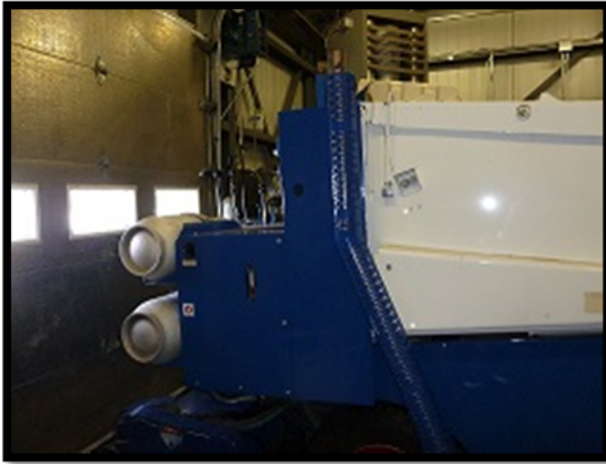
Photo 1

RESURFACER

1. Have the resurfacer's carburetor adjusted by a specialized technician according to the manufacturer's recommendations (**the resurfacer must not be used before being adjusted**). Said adjustment should be performed at least twice per season: before the hockey season and before the scheduled tournaments;

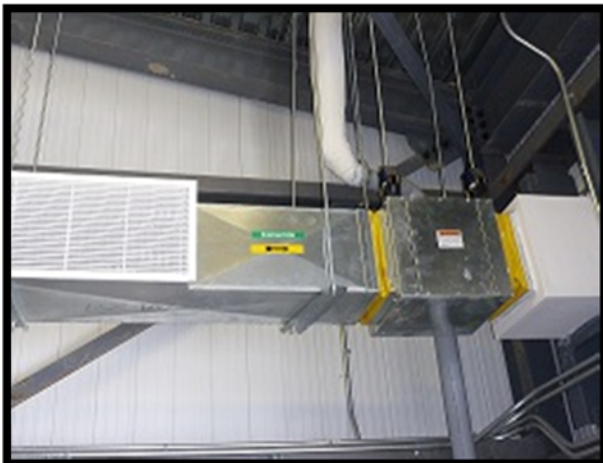
Photo 4

VENTILATION SYSTEM IN THE RESURFACER AREA

6. Turn on the ventilation system manually before using the resurfacer;
7. Take a few readings (2 or 3) around the rink (stands, penalty box) for CO and NO₂ with the Gastec manual pump and tubes to ensure that concentrations are within the norms;

8. Set the ventilation system to automatic (roughly 30 minutes after the resurfacer is turned off).

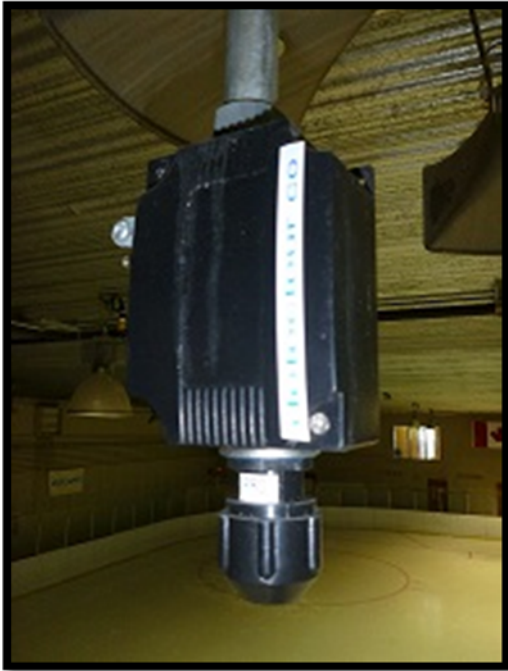
Photo 5

CEILING DETECTOR, IDENTIFIED AS CO BUT SHOULD BE NO₂?

4. Install the detectors behind a grill instead of inside a closed container;
5. Ensure that the ceiling detector in the arena is for NO₂. If not, install an NO₂ detector;

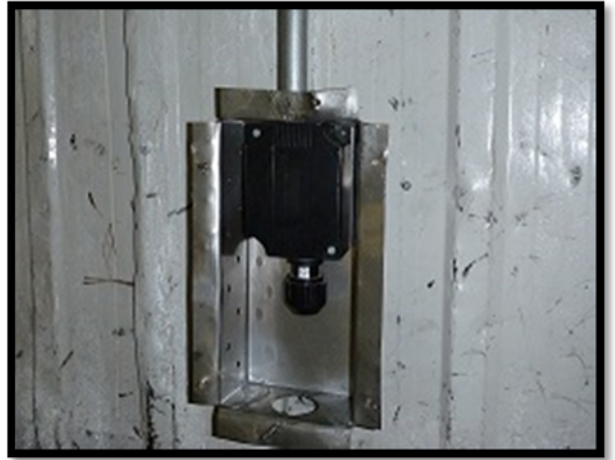
Photo 6

CO DETECTOR AT PENALTY BOX

2. Forward a copy of the certificate of compliance issued by the specialized technician to the Department of Public Health;
3. Check and calibrate the detectors;
